SAFETY ALERT

WORKER SUSTAINED A SEVERELY BROKEN WRIST AND LACERATION INJURY

ZH Alert No: WTE 062

Date of Issue: 23 April 2013

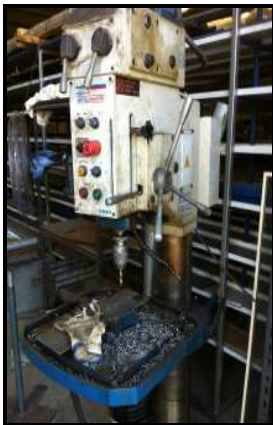
Drill Press

Our 3rd Year Heavy Fabrication Apprentice was using a drill press to drill out 6mm holes in a mild steel plate. The drill bit worked loose whilst touching the job surface.

The apprentice attempted to adjust the chuck whilst the drill press was still running.

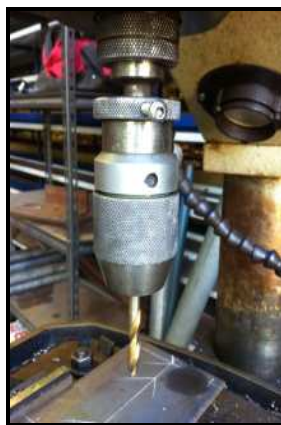
Grub Screw in Chuck

The grub screw on the drill chuck grabbed the apprentice's riggers glove that he was wearing and pulled his hand into the machine causing a badly broken wrist and a severe laceration injury to his hand.

1. The apprentice did not follow Safe Work Practices when using the drill. The drill press should have been stopped before making an adjustment
2. The apprentice was wearing loose fitting leather riggers gloves, not the tight fitting cut resistant HyFlex gloves supplied as part of 1300apprentice's PPE list.
3. The grub screw on the chuck protrudes out from the chuck by approximately 8mm. This grub screw is what grabbed the apprentice's glove.

- Ensure all workers are re instructed on the Safe Work Procedures of the drill press
- Ensure all workers wear a tight fitting glove and clothing when operating any type of rotating machine
- Remove the protruding grub screw (*figure 5*) and replace with a sunken grub screw with no protruding head on it as pictured in (*figure 6*) below.

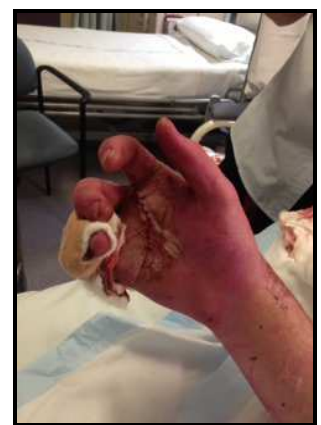
Apprentice Injured Hand

This injury required emergency surgery and an extended stay in hospital for our apprentice.

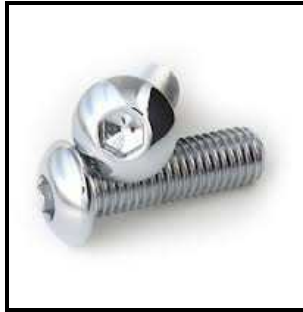
Fig. 5 Grub Screw (Protruding)

- Safe Work Procedures not being followed
- Correct PPE not being worn
- The drill press has a grub screw that protrudes from the chuck.
