## SAFETY ALERT MTI – Crush Injury

ZH Alert No: WTE 46

Date of Issue: 25 January 2012

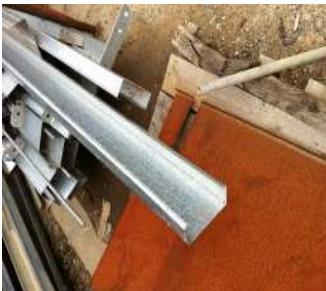
1. The Purlin

Our employee was cutting 8 meter length of purlins down to a required size. He was attempting to drag 4 x 8 meter lengths of purlin down from the racking to the rollers in order to feed into the Hacksaw Machine, he was attempting to work more productively by moving more than one purlin at a time.

The uncontrolled end of the purlin dropped off the racking and the end our employee was holding became too heavy to control. As our employee tried to let go the purlin dropped onto his index finger causing a crush injury requiring medical treatment.

The load the apprentice was lifting was too great and it was also at an awkward length. Our employee needs to follow standard manual handling techniques and ask for help when performing this type of lift.

- All employees be made aware of correct manual handling techniques
- Host employer will need to address the racking system to ensure the steel being slid from the racking to the rollers can not slip to the floor. Welding additional vertical brackets on the ends of the existing brackets can alleviate the risk.

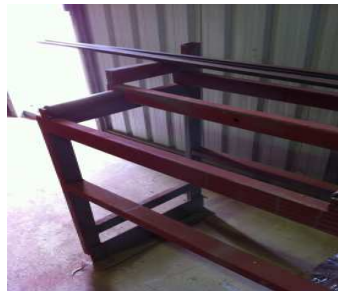
2. The racking and roller

The racking system allowed the purlins to slide off at the uncontrolled end.

- The employee performing a two person lift on his own in order to work more productively.
- The racking system being inadequate to stop the purlin from dropping to the ground.
