SAFETY ALERT LTI – Laceration

ZH Alert No: STE170

Date of Issue: 20/01/2012

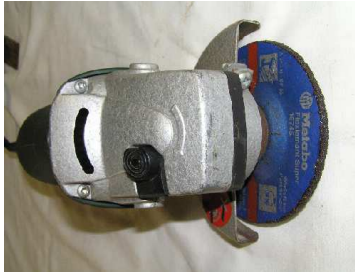
1. Five Inch Grinder

An employee suffered a serious laceration injury whilst using a five inch angle grinder to grind the hand rail that was previously welded.

The employee had his index finger caught between the spinning blade and the guard causing a laceration.

Our employee was facing away from his work that he was grinding. He started the grinder prior to turning around and facing the job surface.

When he turned the job was closer then he thought to his body, causing him to bump his elbow on the job, this made him lose his grip on the grinder and his finger slipped between the blade and the grinder guard.

- Starting the grinder prior to turning around and facing the job surface.
- Inexperience with the safe use of the grinder
- Lack of training on Safe use of the grinder

- Host employer to retrain the employee on the safe use of the angle grinder
- Employee to ensure that they are facing the job surface prior to starting any type of machinery

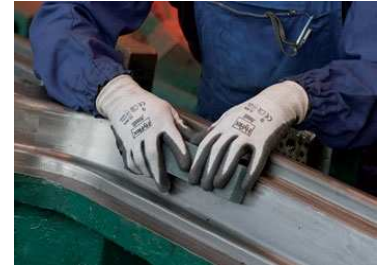
3. Gloves

This employee's injuries could have been much worse if he was not wearing gloves.

Always wear PPE provided by 1300apprentice and your host employer.
